Section 3: Looking Downstream from State Street Bridge
Average Water Surface

Section 2: Looking Upstream from Main Street Bridge
Average Water Surface

Section 1: Looking Downstream from E. Pleasant Street
Average Water Surface

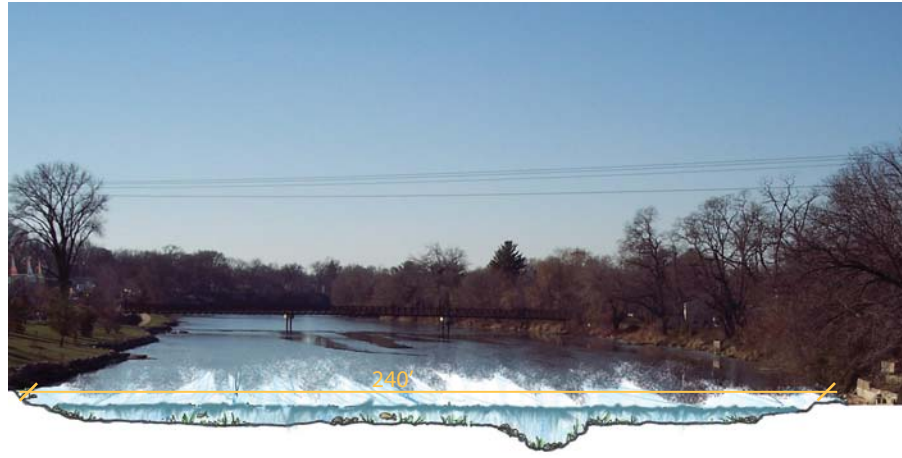
Existing Conditions

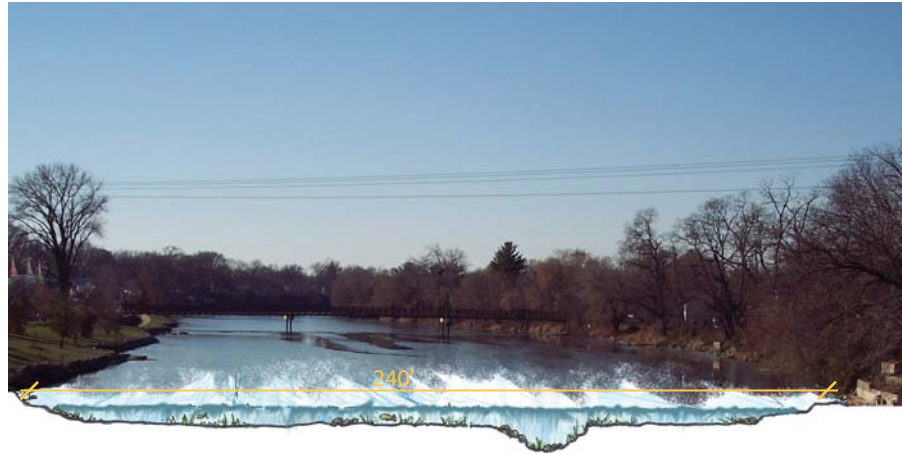
Rock Ramp Alternative & Bypass Alternative
No Change from existing

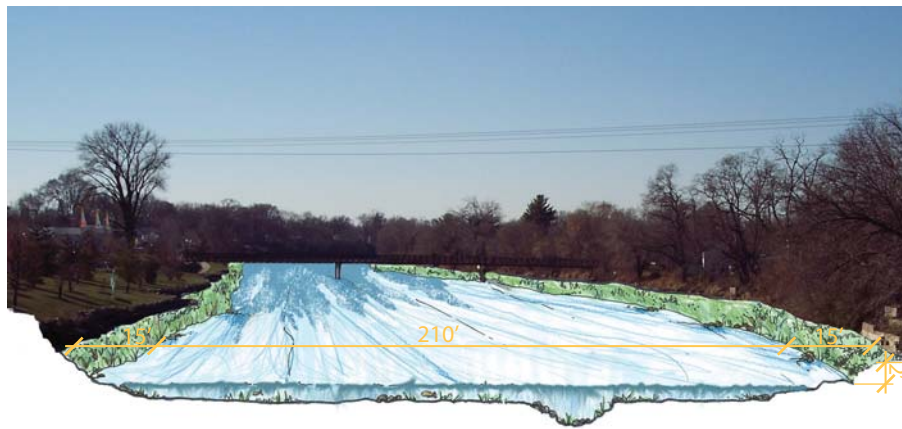
Dam Removal Alternative
Lowered 2 feet from existing

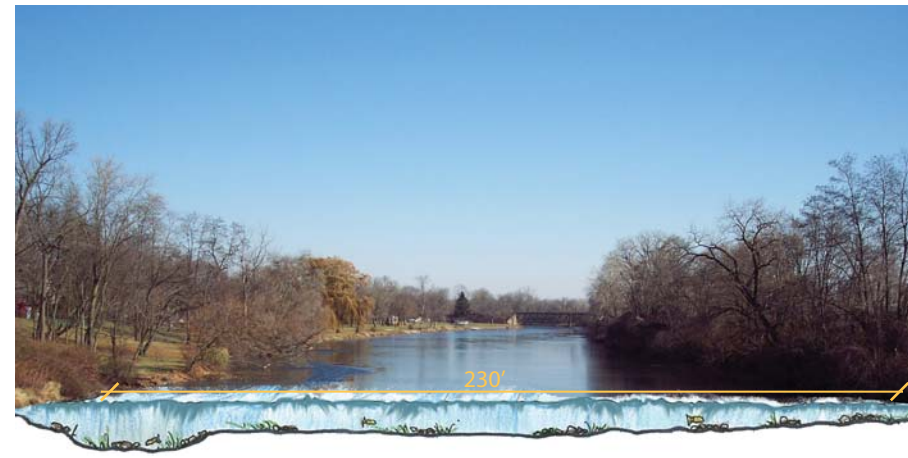
Existing Conditions

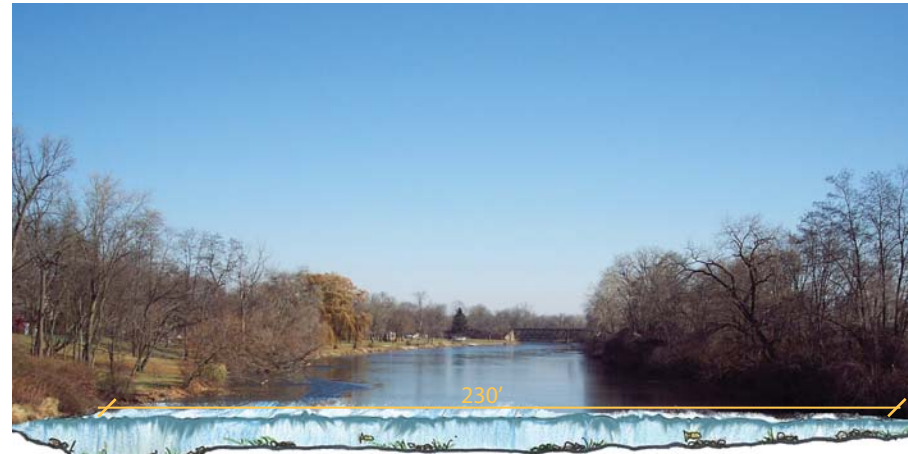
Rock Ramp Alternative & Bypass Alternative
No Change from existing

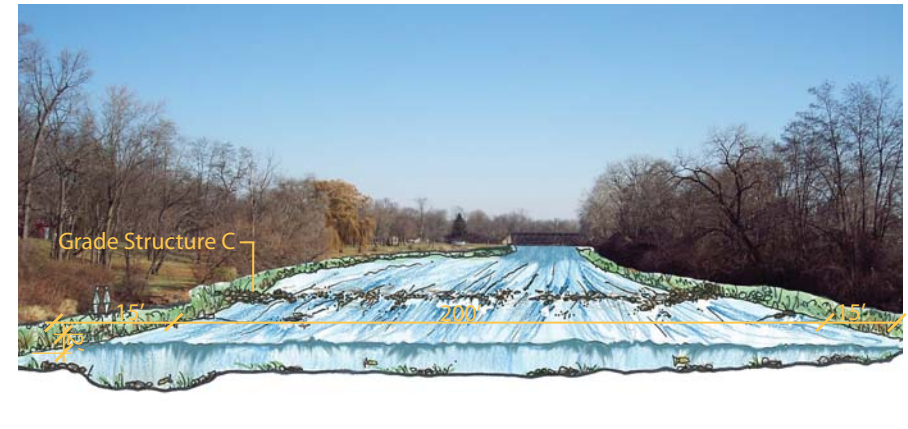
Dam Removal Alternative
Lowered 2 feet from existing

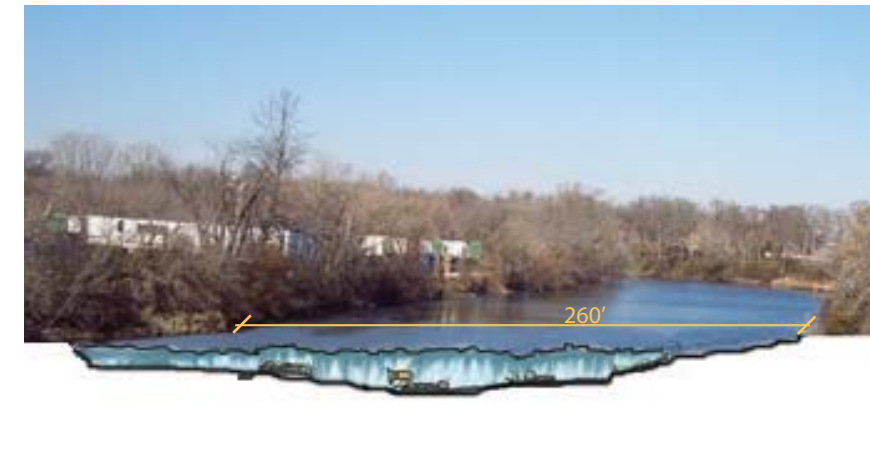
Existing Conditions

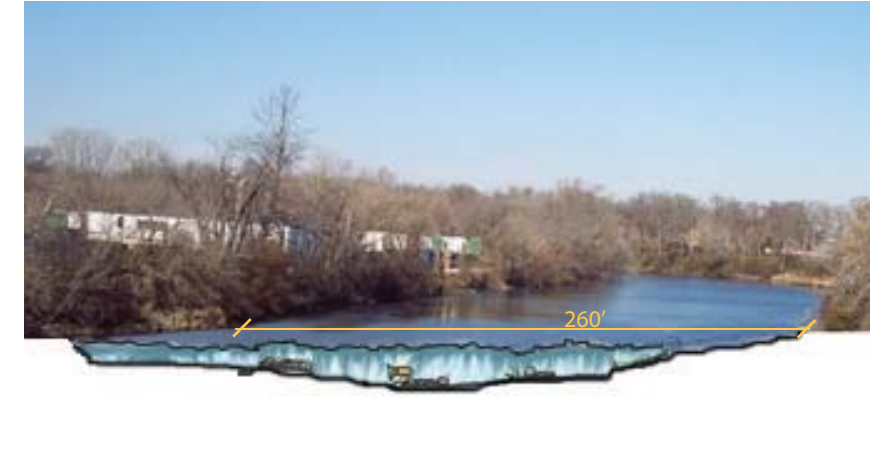
Rock Ramp Alternative & Bypass Alternative
No Change from existing

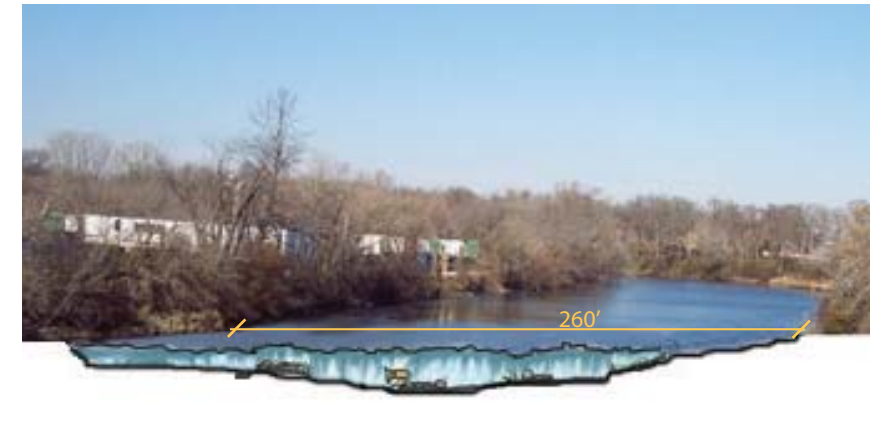
Dam Removal Alternative
No Change from existing
